# N2NA Pylon Overheat Mishap

Bart Henwood  
Board Chairperson  
1 Dec 07

- \$605K in damage to fuselage structure and pylon panels
- Proximate Causes –
  - Precooler coupling installed without retaining ring allowed 400 deg F/40 psi air to damage structure and disable primary warning system (SPF)
  - Wiring to the pylon hot warning system temperature sensor broke, disabling the system and preventing the primary aircrew warning of the bleed air leak condition.
- Root Causes – None
  - Did not uncover any systemic organizational factors

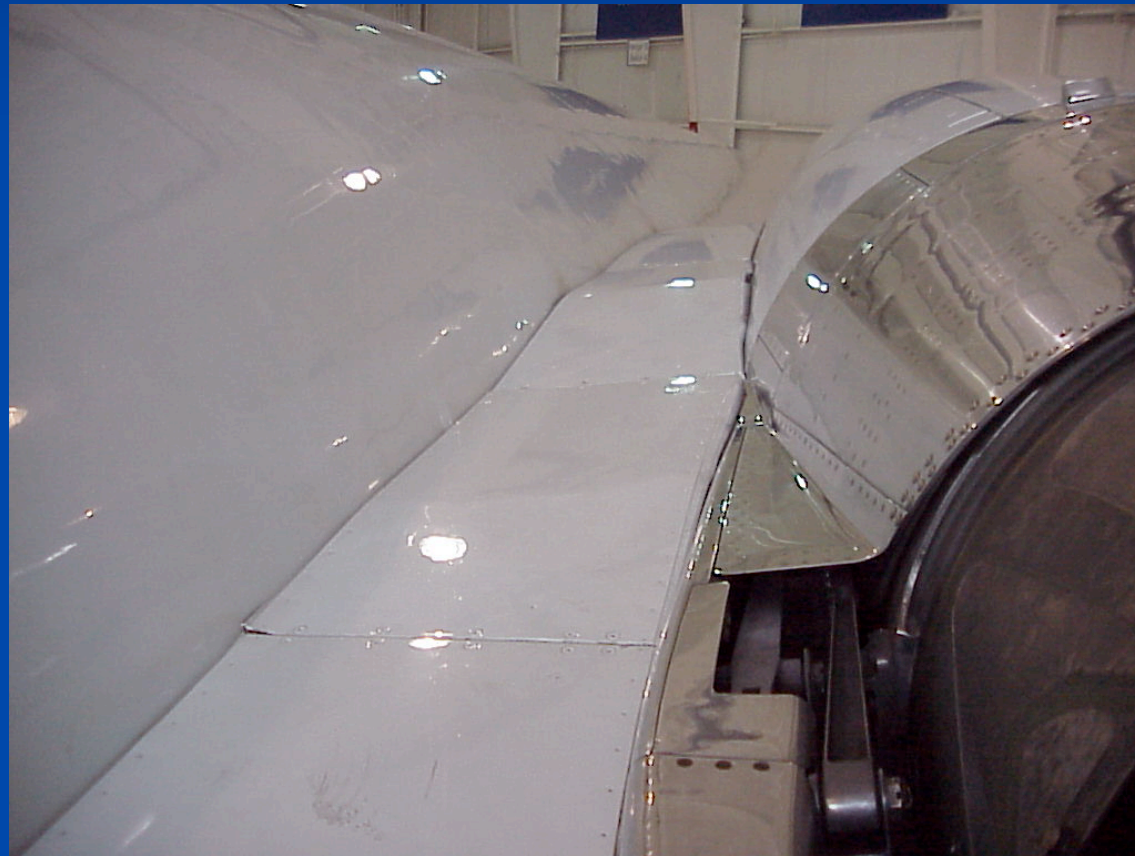
Right Pylon Panels Found Buckled

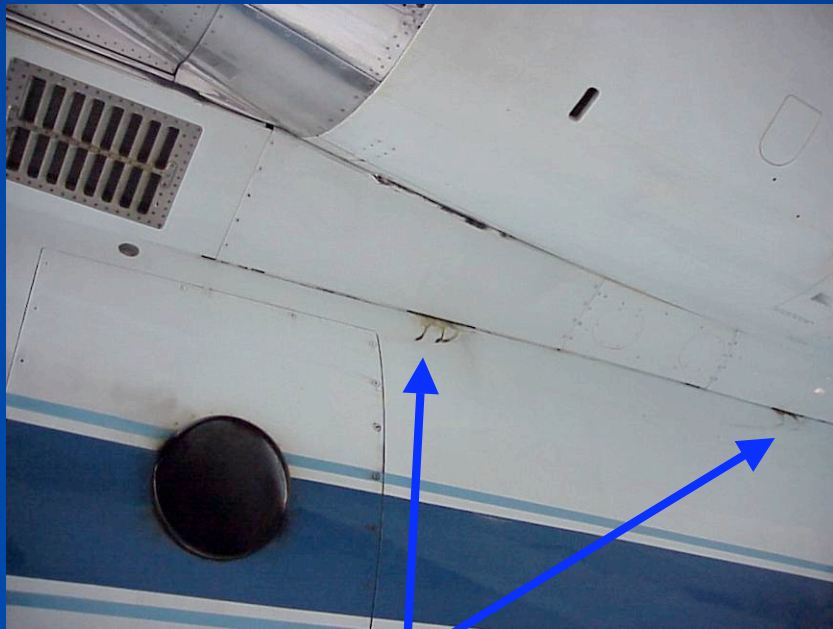
Evidence of possible Forward and Aft  
Engine mount isolator heat damage

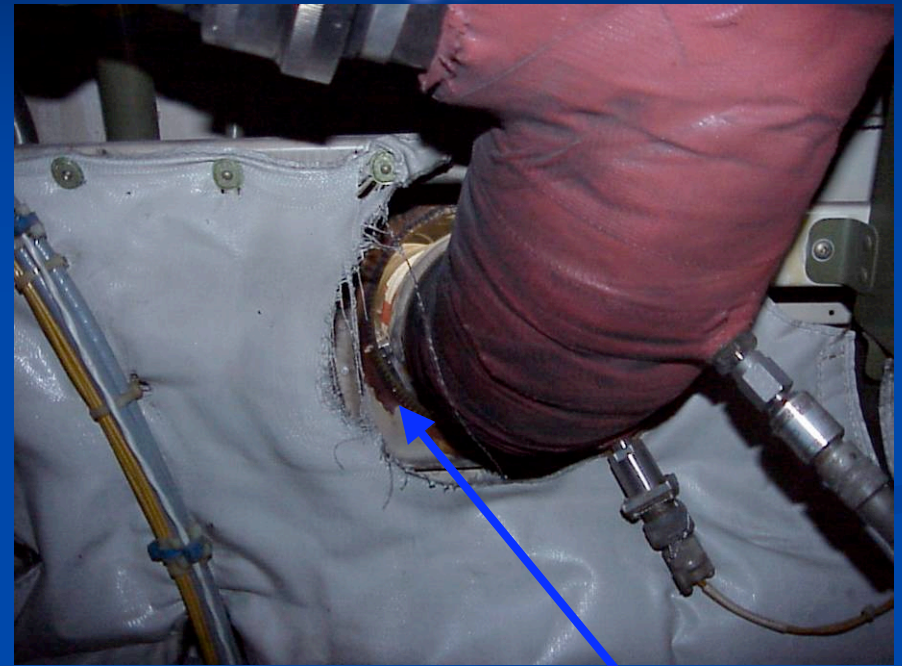
Aft Equipment Bay Heat Damage

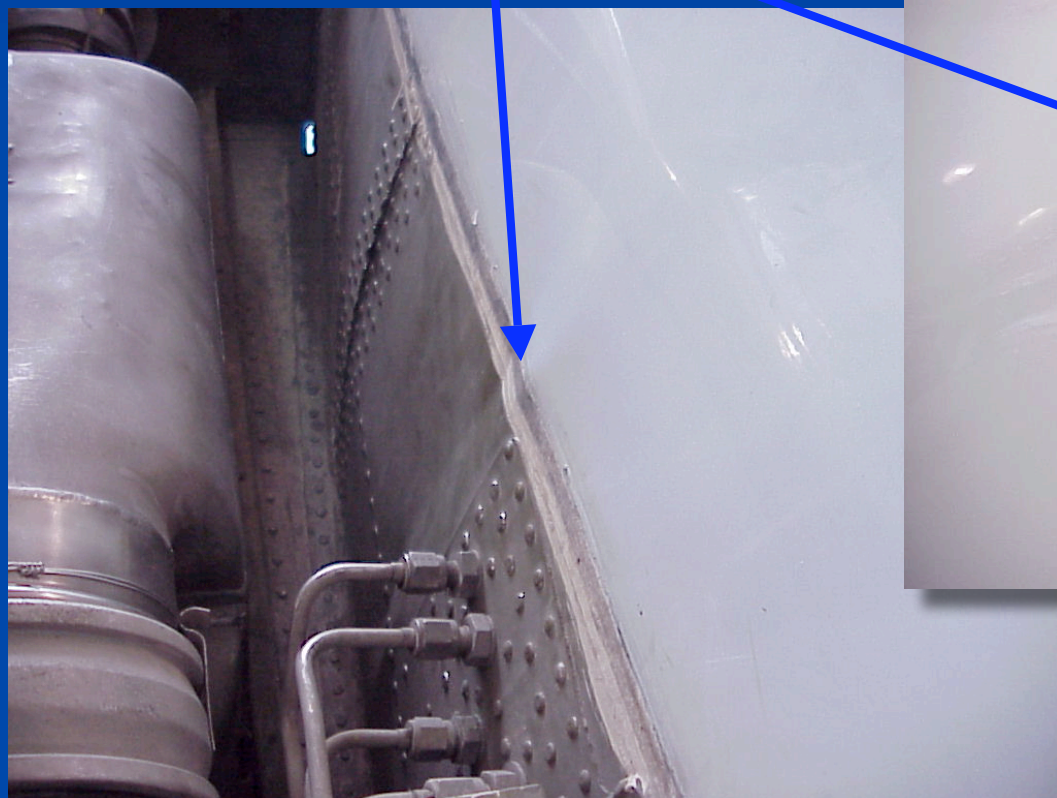
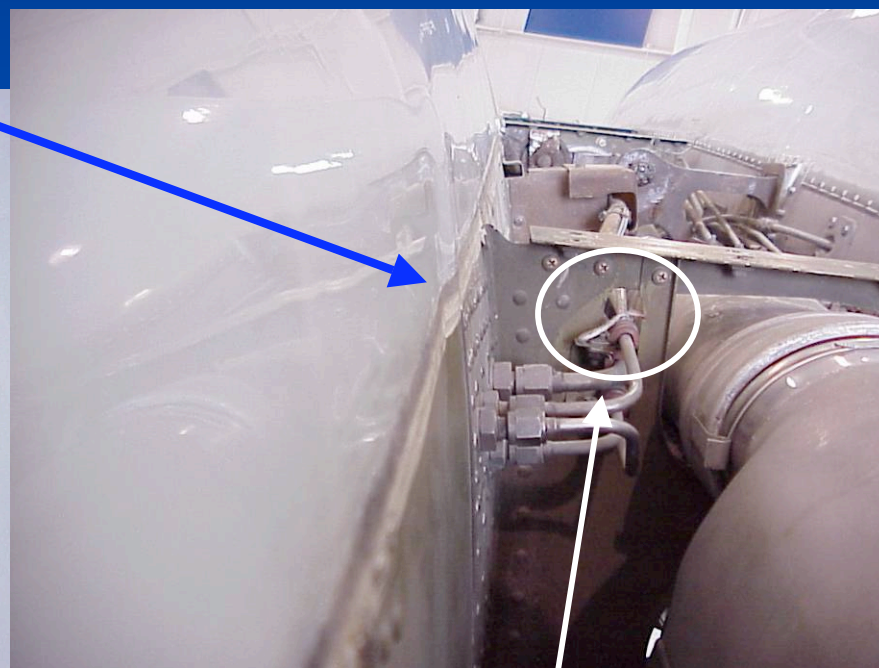
Fuselage Skin Buckled

Pylon Hot Sensor Wire

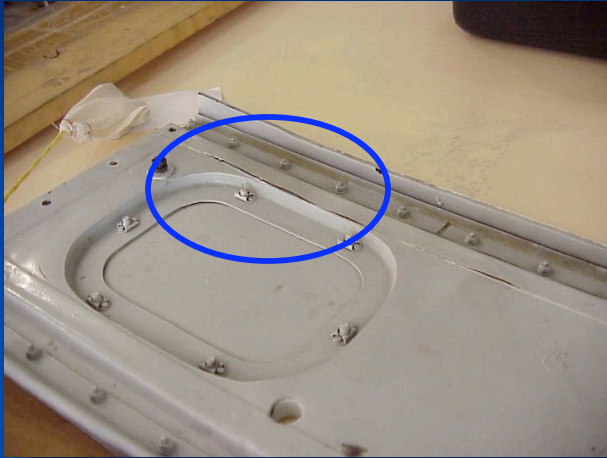
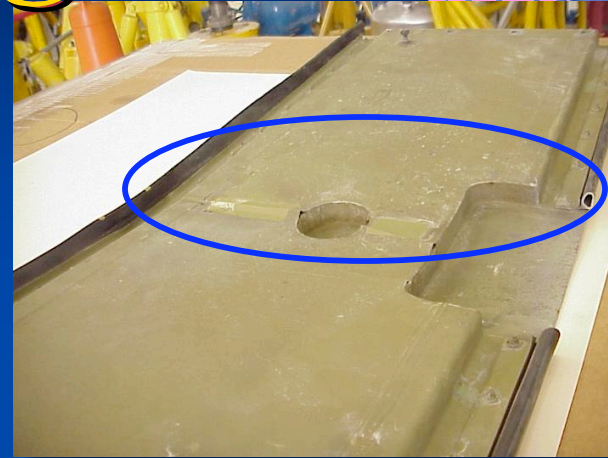
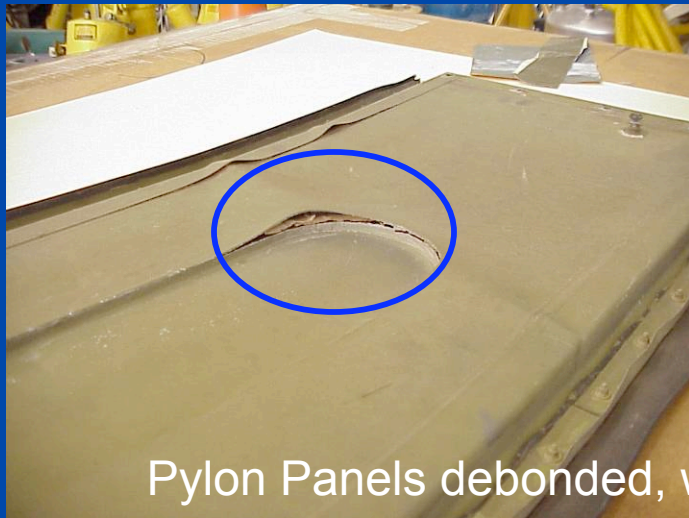
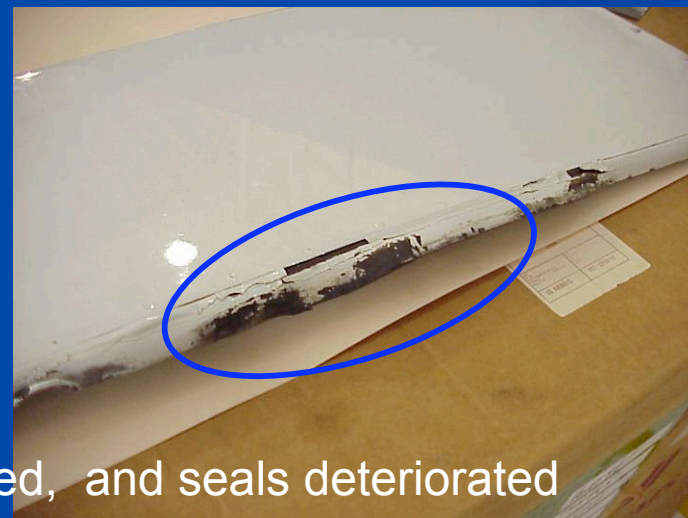
Pylon Panels debonded, warped, and seals deteriorated

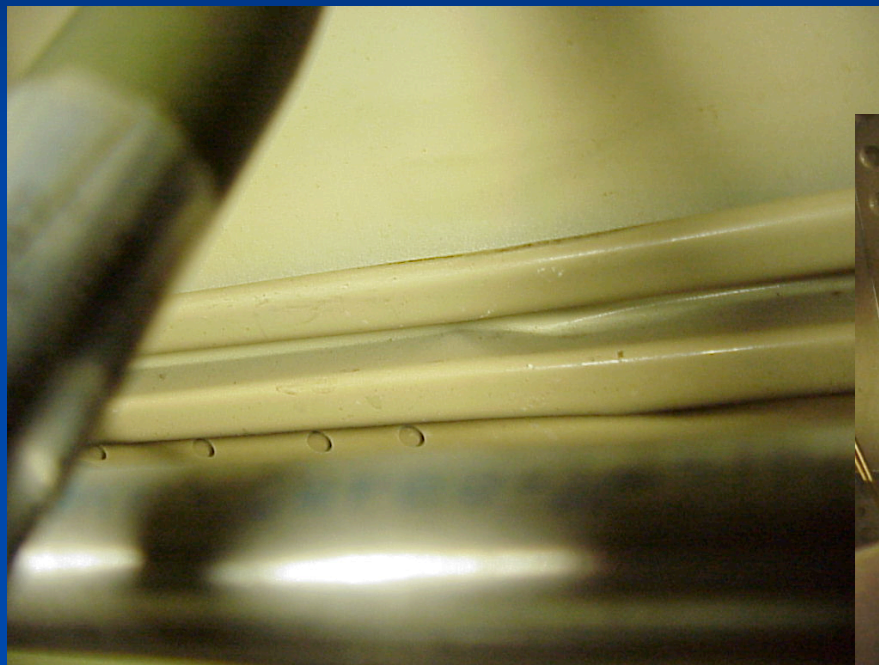
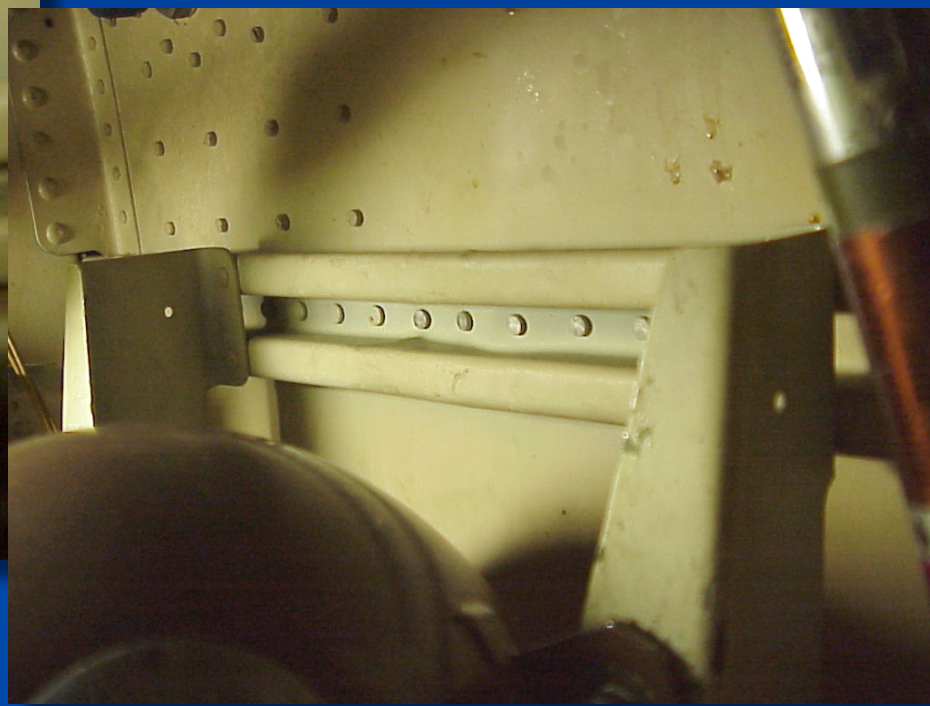
FS 610- Stringers #9 and #10 Right Damaged

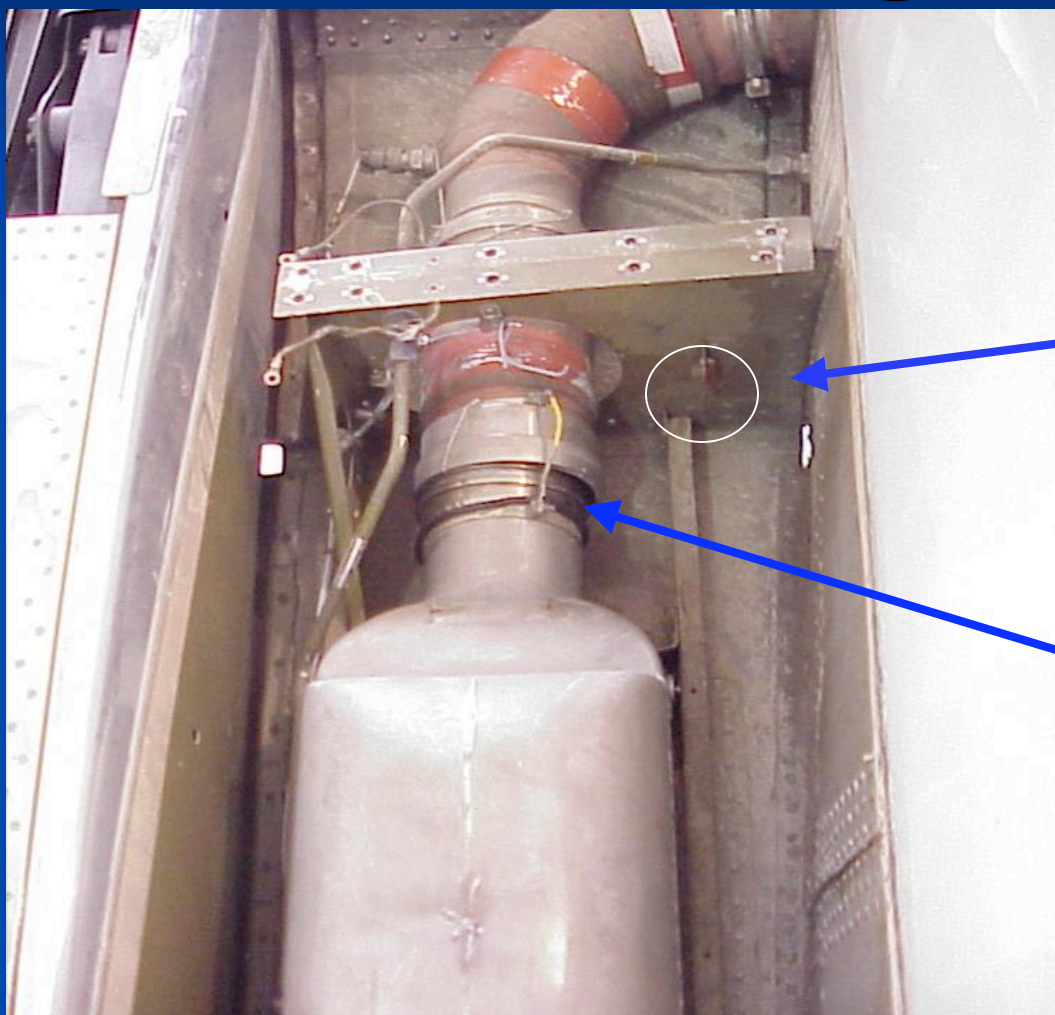
Pylon Hot Sensor

Right Precooler  
HP Exhaust Coupling

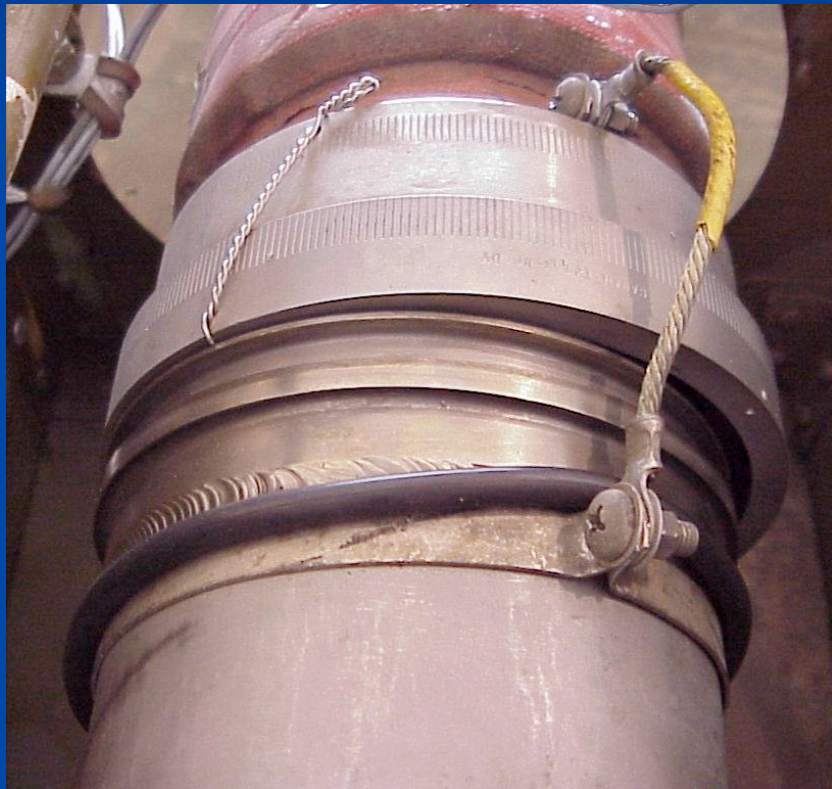
Coupling and O-ring displaced

- Correct maintenance technical data and improve config control to prevent RR absence
- Redesign the Pylon Hot Warning System for the NASA fleet to improve sensor wiring integrity
- Inspect for RR just prior to installation
- Bar trainees unqualified in task from signing off work as primary technician

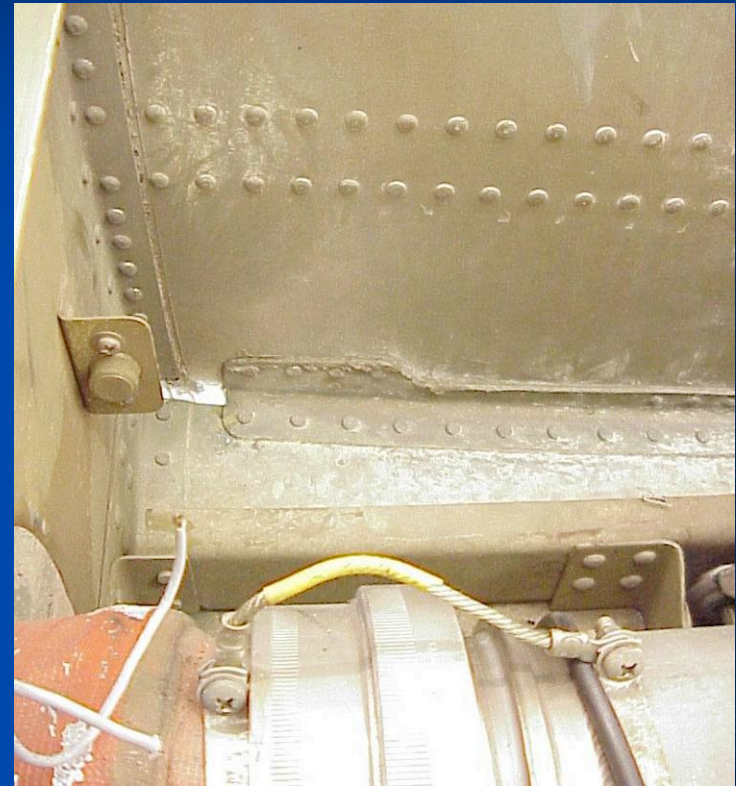
Pylon Hot Light Sensor  
Wires Broken
